LETTER TO THE EDITOR

Difficult ventilation due to an undetected mask crack

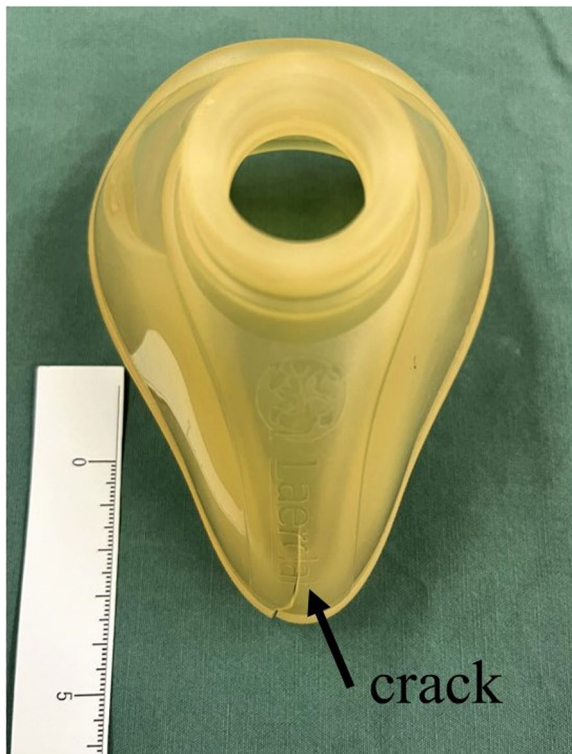
The responding anesthesiologist, feeling discomfort in his left hand holding the mask, identified a crack in the mask (Fig. 1), promptly replaced it, and restored effective mask ventilation, presenting the V1 waveform on capnography. During the period from preoxygenation until intubation, the patient's minimum percutaneous oxygen saturation reached 78%.

First reported mask breakage in our OR. We posit that the ventilation challenge stemmed from the unnoticed mask crack, as ventilation only improved after mask replacement. It is likely that the crack was present prior to the preoxygenation phase, given that the capnography waveform did not exhibit the V1 reading until the mask was replaced. The minute size of the crack may have limited airway pressurization, resulting in partial ventilation. Unfortunately, efforts to manually adjust mask pressure inadvertently exacerbated the crack, rendering airway pressure maintenance impossible. The exact duration of use for this mask remains uncertain due to incomplete records. Upon reviewing a photo of the damaged mask, the manufacturer noted discoloration, indicating potential silicone deterioration that might have contributed to the cracks, highlighting an increased risk of breakage.

Fig. 1 Anesthesia mask with crack

In this case, the pre-anesthesia equipment examination adhered to the "Checkout Procedures of Anesthesia Apparatus" [1], but did not encompass a detailed mask inspection. We recommend an extension of the current protocol to include such an assessment, which could have potentially prevented this incident.

This case underscores the critical importance of meticulously inspecting the anesthesia mask during pre-operative checks. Anesthesiologists must receive education regarding their pivotal role in safeguarding patient well-being.
